FPR-4-005 Issue No. 27 30 April 1962

PROJECT QUICK CHECK MONTHLY PROGRESS REPORT

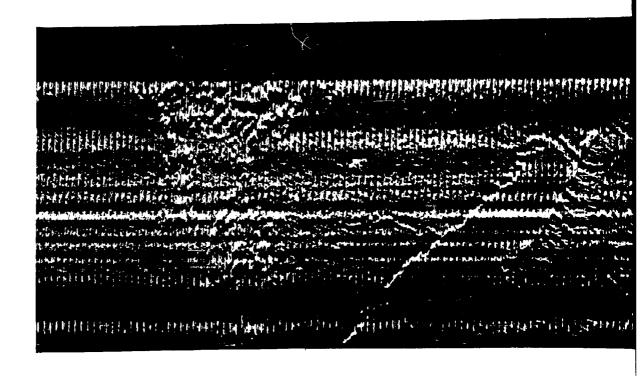
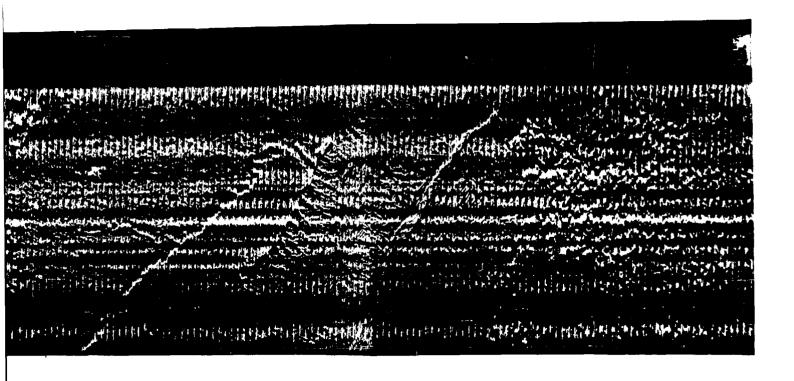
Figure 2. AAR-19 Infrared Receiver - Lake McConaughy, Nobraska Area; Flight No. 14; Altitude 30,270 feet; Heading NW

Figure 2 is a picture of Lake McConaughy, Nebraska, taken on Flight No. 14. This IR picture is representative of the best results obtained to date, with the AAR-19 at GD/FW. However, there are two discrepancies in this data that are not representative of a typical flight (1) a longitudinal bar through the center of the picture and (2) discontinuities of straight lines. The longitudinal bar is a result of the center structural bar reflector not having been installed prior to this flight. The discontinuities are a result of an improper V/H signal to the AAR-19 scanner. This resulted from approximate manual V & H inputs having to be used instead of the usual N3A output, which was unavailable due to an N3A malfunction.

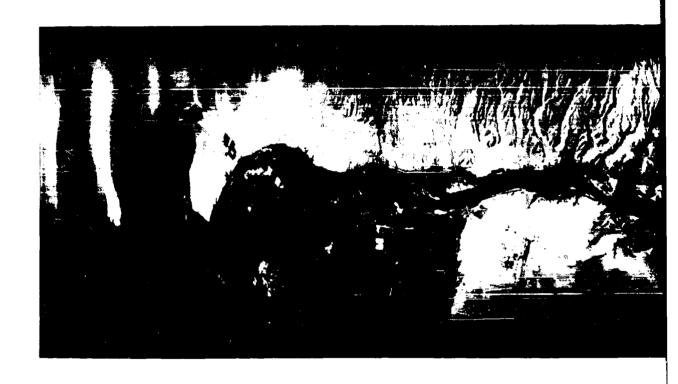
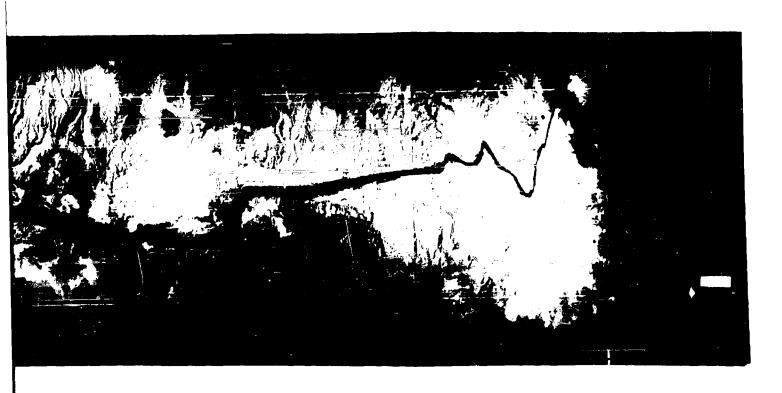
Figure 4. F-415 Camera - Parker, California and Colorado River; Flight No. 19; Altitude 36,730; Heading 324.7; Ground Speed 487 knots

Figures 3 and 4 are photographs taken on Flights No. 12 and 19 respectively. These pictures represent the quality of pictures the F-415 camera is capable of obtaining. It should be noted, however, that Figure 4 was taken under a condition of low light level and a thin coat of oil on the camera window.

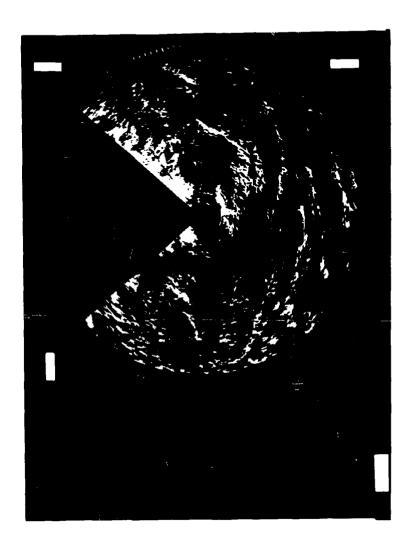
Figure 5. AN/APQ-77 (XH-1) Radar System Photo - Fort Huachuca Radar Resolution Range; Flight No. 19; Altitude 35,170 feet; Heading 89.2 degrees; Ground Speed 565 knots

The APQ-77 functioned properly throughout the entire flight. The negative of the flight was slightly darker than was desired, but the duplicate positives which were reproduced were of excellent quality. (See Figures 5, 6, and 7.) Even ground paint is evident throughout the entire video display. The video clipping level will be slightly reduced for the next flight to decrease the film density of video display.

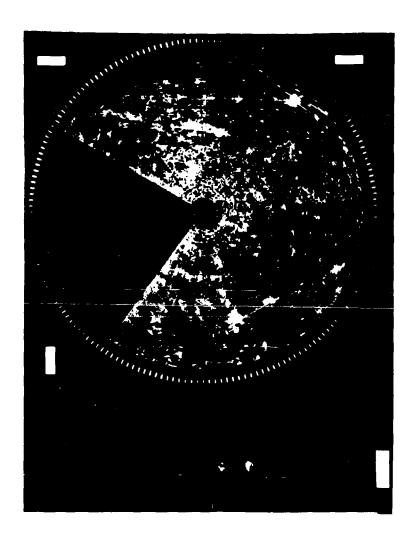
Figure 6. AN/APQ-77 (XH-1) Radar System Photo - Midland-Odessa-Lubbock Area; Flight No. 19; Altitude 33,400 feet; Heading 77.1 degrees; Ground Speed 562 knots
